Flexible Pipe Integrity Management Guidance & Good Practice

Prepared for: Sureflex JIP Members
Doc Ref: 807511-00-IM-GLN-001
Rev: 05
Date: December 2023

JIP Report

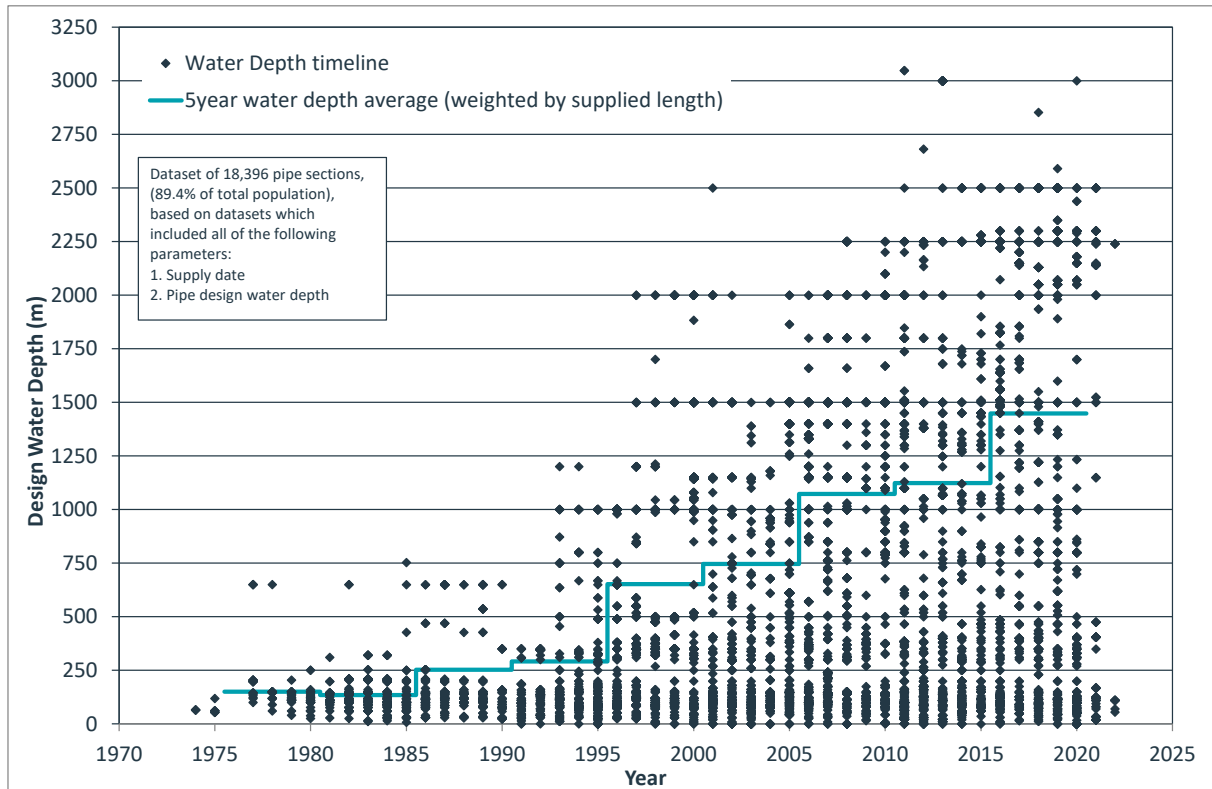
Figure 3.7 Design Water Depth (m) Timeline

- The **design water depth** 5-year averages (Figure 3.7 show a continuous and significant increase, with a step change in the last 5-year period from 1,124 to 1,448 metres. As noted up front, these trends are not a measure of manufacturer capability, and in addition may be affected by large supply contracts and multi-section deepwater pipes, where a common (maximum) depth requirement is specified. The corresponding histogram (Figure 3.8) shows increases in deepwater applications in the recent period and a corresponding decrease in the shallower depth ranges, as follows;

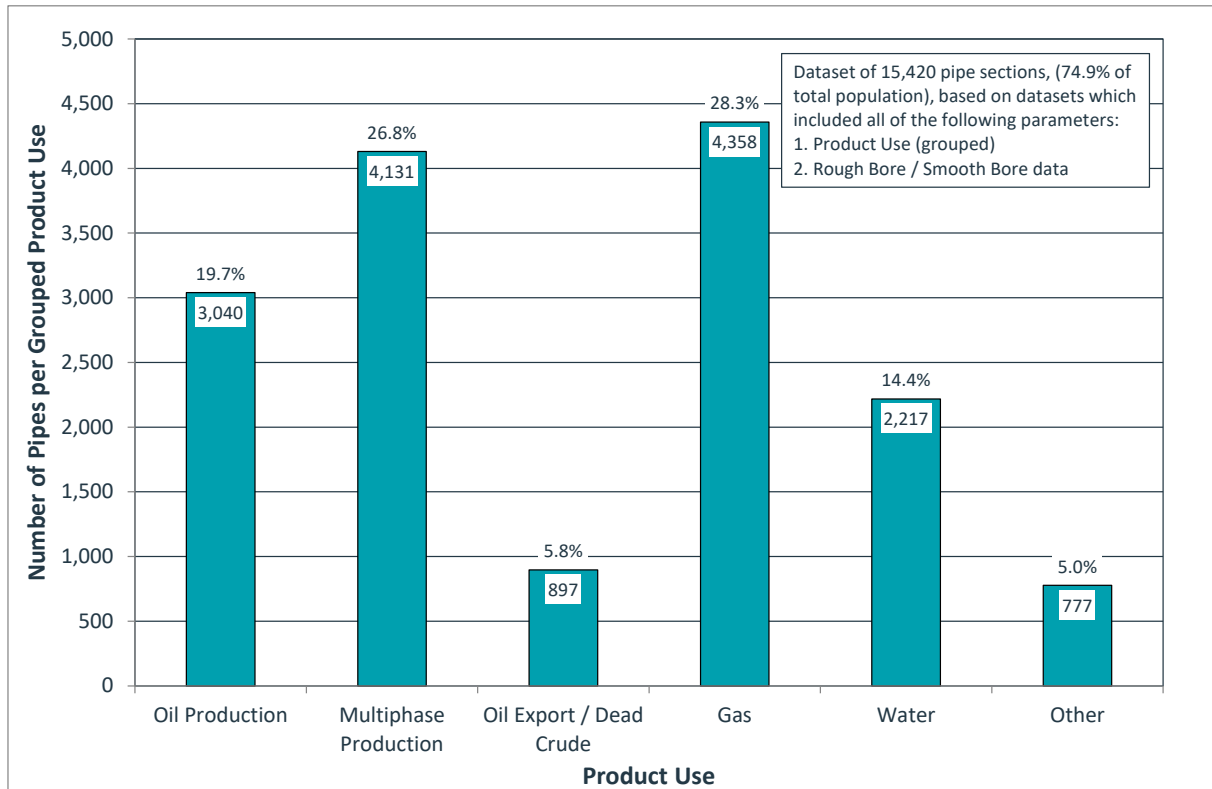
Figure 3.13 Flexible Pipe Product Use

- Figure 3.13 gives a breakdown of pipe product use into six consolidated groups, and Figure 3.14 presents the corresponding split of smooth bore / rough bore applications for each of these groups. The majority of these six groups are significantly dominated (each >96%) by rough bore products. As expected, the key outlier is for pipes in water service, where 64% of supplied pipes are smooth bore (the corresponding subsets for Risers and Flowline&Jumper applications have smooth bore designs for 51% and 68% of supplied pipes).

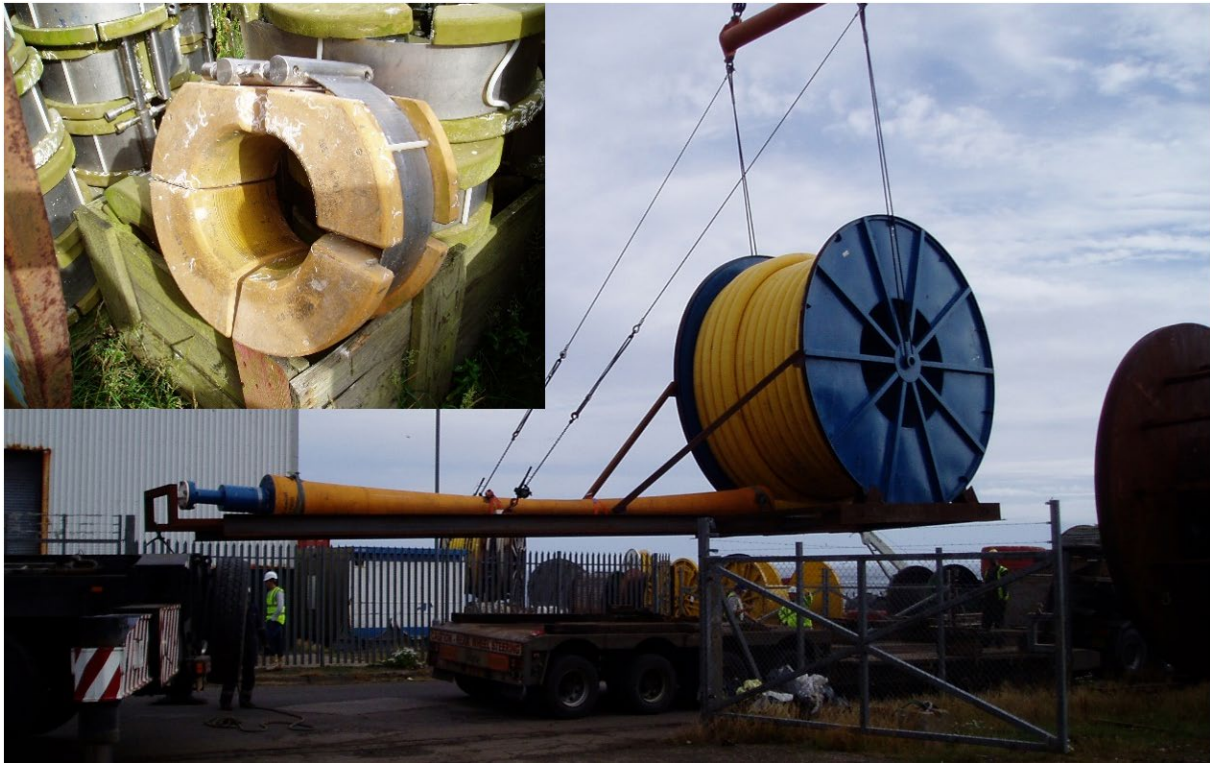
Figure 9.1 Dynamic Flexible Riser Re-use

Wood shared experience of a 6-inch, 206m long dynamic riser that was recovered after 3 years operational service in a North Sea steep-wave application and then re-configured for a shallow water dynamic riser application in another offshore region, linking a fixed wellhead platform with an FPU. In this example, the riser was not re-terminated and instead the fixed length determined the FPU location. A number of buoyancy module assemblies were re-used as were the topside and subsea bend stiffeners as shown in Figure 9.1. Wood is aware of another North Sea example, Ref. [34], where the flexible pipes were recovered after less than 2 years service and also sold to a third party for re-use in another region. In both cases, the re-use potential arose from underperforming field reservoirs and premature cessation of production, although there is no documented feedback from the re-use application.
